a case study with different attempts to stop the moisture

Møller, Eva B.; Olsen, Birgit

Published in:
9th Nordic Symposium on Building Physics

Rising damp, a reoccurring problem in basements – a case study with different attempts to stop the moisture

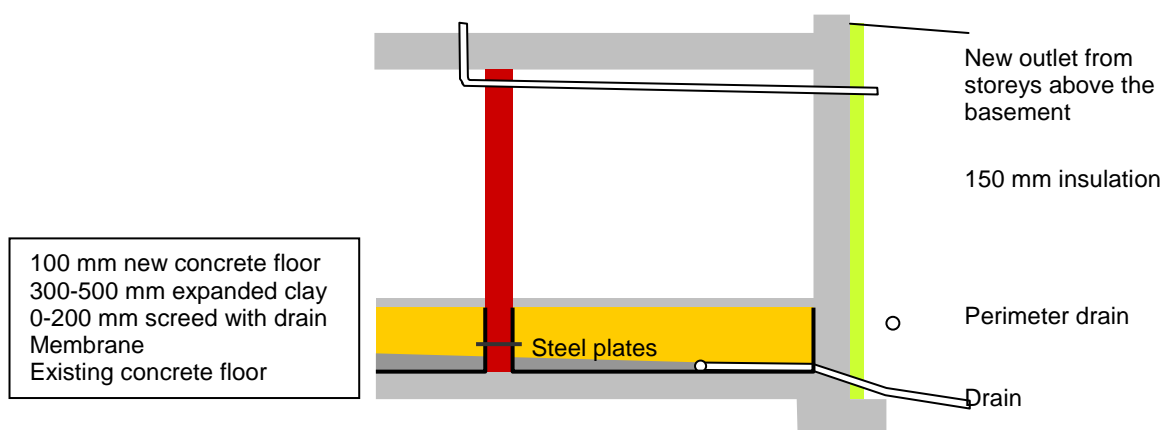
- *Steel plates and injections.* To stop the rising damp in the internal brick walls it was planned to use the liquid membrane, removing 2 courses of the brick wall approximately 1 m at the time. This was difficult and time consuming. Instead the contractor chose to force overlapping steel plates through a horizontal joint where they acted as a capillary suction barrier. Where it was impossible to place steel plates e.g. because of downpipes in the walls, it was planned to inject the area of the wall with a capillary blocking mortar, however, this was never done.

FIG. 1. Schematic drawing of remedies to reduce moisture transport into the basement. Originally the membrane was planned to be continuous e.g. under the internal walls, but this was later changed by the contractor. Instead steel plates were pressed through the walls, and the membrane was continued on the wall.

- *New floors.* Although the concrete floor was placed on sand, the moisture content, indicating that capillary suction was possible through the sand and concrete. As the ceiling height in the basement was 3.28 m, it was possible to raise the floor and create a double construction by placing a new floor at a higher level. The area between the two floors was drained. To stop rising damp through the floor a liquid membrane was applied on the original floor.

- *Outer walls.* The concrete walls were un-insulated and the drainage defective. Therefore, perimeter drain and 150 mm external insulation (EPS) were added to the walls. Pumps to insure the drainage was effective were also installed. The pumps were provided with an alarm system, telling the caretaker when the system had fall outs.

- *Sewage system.* The sewage system was changed; sewage from upper storeys was placed higher than originally and only outlets from the basement were placed under the new basement floor.

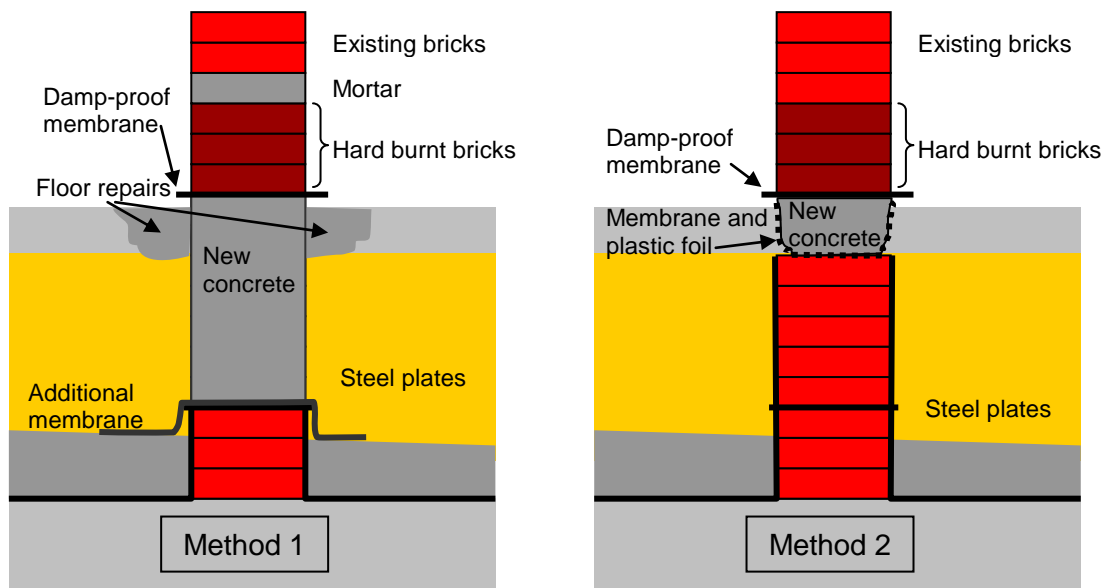
FIG. 3. First method to avoid moisture transport in internal walls, ten courses of bricks had to be replaced in this solution (left). In the second method the concrete floor was untouched and only five courses had to be removed (right).

The two solutions did not show significant differences in effectiveness, and will therefore be treated as one. The main principle in the solutions was to stop rising damp also if the water was under pressure, due to a high groundwater level.

After more than four years the test area was still wet, indicating that the rising damp was not stopped. However, the moisture could come from the untreated parts of the wall; therefore, horizontal capillary suction was stopped by milling a groove at both sides of the test area. At the same time the wall was dried forcefully.

were performed. Different solutions were tried; the first was regarded more safe than the second but also more expensive. Both solutions are presented in FIG. 3.

As both methods included removal of bricks, it was not possible to renovate the whole wall at once, but the wall had to be divided in bits, making it possible to have a gap of maximum 1 m and solid wall on both sides of the gap. Theoretically every other meter of wall could be renovated at the same time. When the gap was closed, the adjacent wall piece could be renovated. However, a part of the wall had to be left open between the two similar work processes, as the liquid membrane had to overlap.

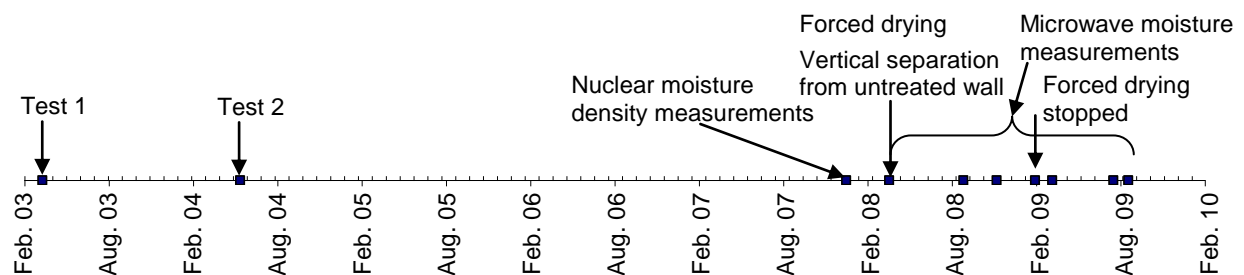
The moisture content in the wall above the two test areas was measured several times in the period from December 2007 to August 2009, see FIG. 4. This also included few determinations of moisture content based on weighing and drying of specimens from the wall.

FIG. 4. Timeline of the tests and following moisture measurements.

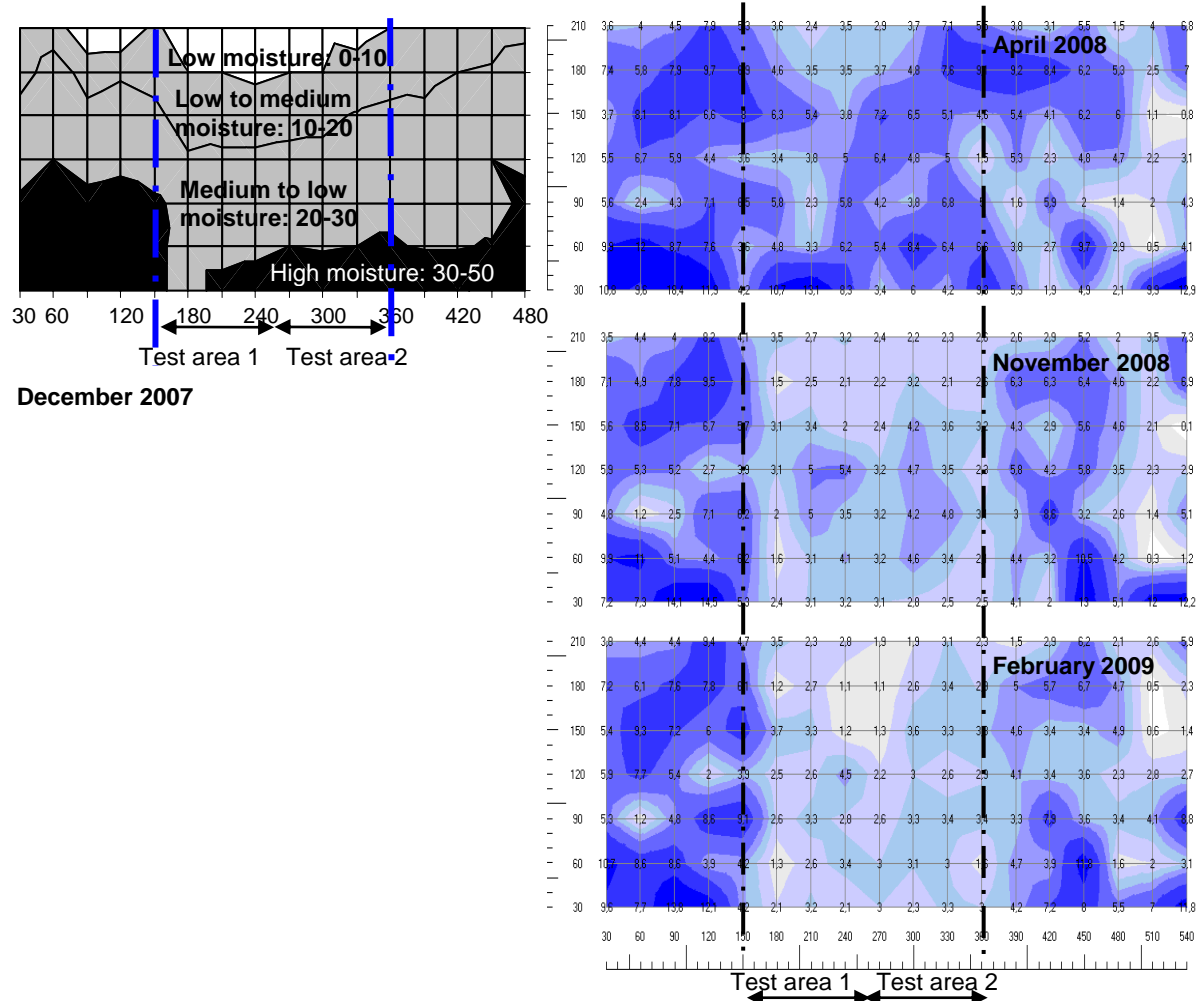
Measurements with nuclear moisture density gauge are shown in FIG. 5. The measurements are shown as numbers that resembles the moisture content; high numbers indicates high moisture content. The measurements were performed in December 2007, 4½ years after the two tests were performed; e.g. rising damp was blocked horizontally but not vertically. The basement was heated and ventilated during this period. Moisture content in brick and mortar was determined by weight to 21 % in brick and 6 % in mortar in an area where the nuclear moisture density gauge showed high moisture content.

FIG. 5. Moisture measurements with nuclear moisture density gauge with numbers resembling the moisture content (left). Microwave moisture measurements (in weight % of bricks) (right); when the test areas were separated from the rest of the wall and forced drying activated (April 2008) and after (November 2008 and February 2009). The measurements after the forced drying was stopped (February 2009) did not show significant changes and were similar to those from February 2009.

Like the measurements with nuclear moisture density gauge the first microwave moisture measurements showed that there was only little difference in the moisture distribution in test area compared to the untreated parts. The lower parts were moister than the upper parts although the image was more blurred, with some wet areas higher up in the wall. It seems more likely that the walls are moister at the bottom than at the top, as the measurements with nuclear moisture density gauge showed (FIG. 5 left), than a random distribution as the microwave moisture measurements showed (FIG. 5 right).

However, the general picture of decreasing moisture content over time, which was seen in the weight measurements, is recognisable in FIG. 5. The microwave moisture measurements may not give exact information on the moisture content in a particular point but can be useful as a picture of how the moisture distribution changes over time.

After the moisture content in the test area had stabilised (after less than a year, cf. FIG. 5), the forced drying was stopped, and microwave moisture measurements continued. The moisture distribution did not change after the forced drying had stopped. Therefore, rising damp in the internal walls had stopped; the tests were successful. As a result the second test solution is now being applied to all the internal walls. After a drying period the moisture content will be checked with microwave moisture measurements combined with moisture measurements by weight.
